**OPERATION OF A FORCED CIRCULATION,
CROLOY 9 M, MERCURY LOOP TO STUDY
CORROSION PRODUCT SEPARATION TECHNIQUES**

by D. B. Cooper and E. J. Vargo

Prepared under Contract No. NAS 3-2538 by
THOMPSON RAMO WOOLDRIDGE, INC.
Cleveland, Ohio

NATIONAL AERONAUTICS AND SPACE ADMINISTRATION • WASHINGTON, D. C. • APRIL 1965

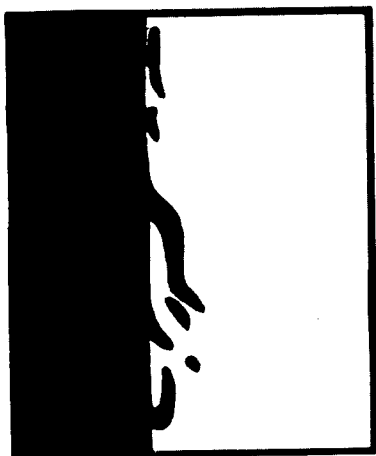
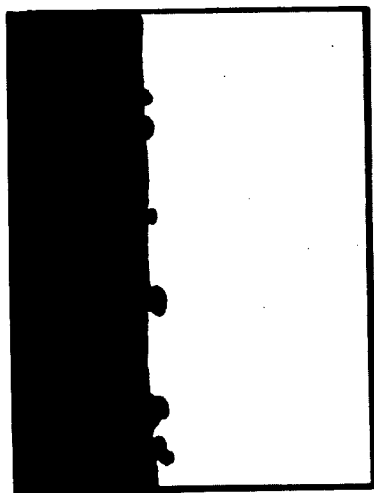
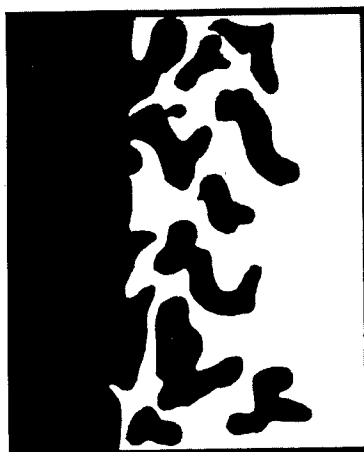
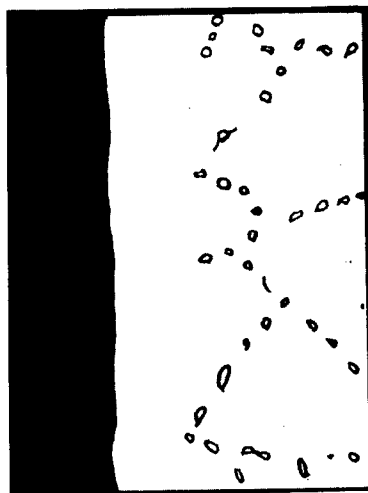
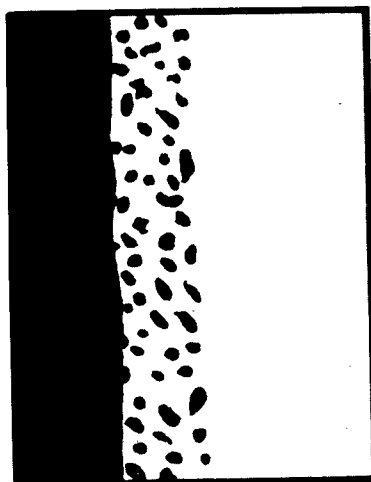
Figure 30. Examples Illustrating Types of Corrosive Attack.

A summary of the corrosion observations made by metallographic examination is listed in Tables 4 and 5. Corrosive attack was classified according to the chart presented in Figure 30 on the basis of microstructural examination. Representative photomicrographs illustrating the typical appearance of the loop sections are presented and will be specifically referred to in the following portions of this report. For comparison, reference is made to the microstructure of the as-received material illustrated in Figure 16.

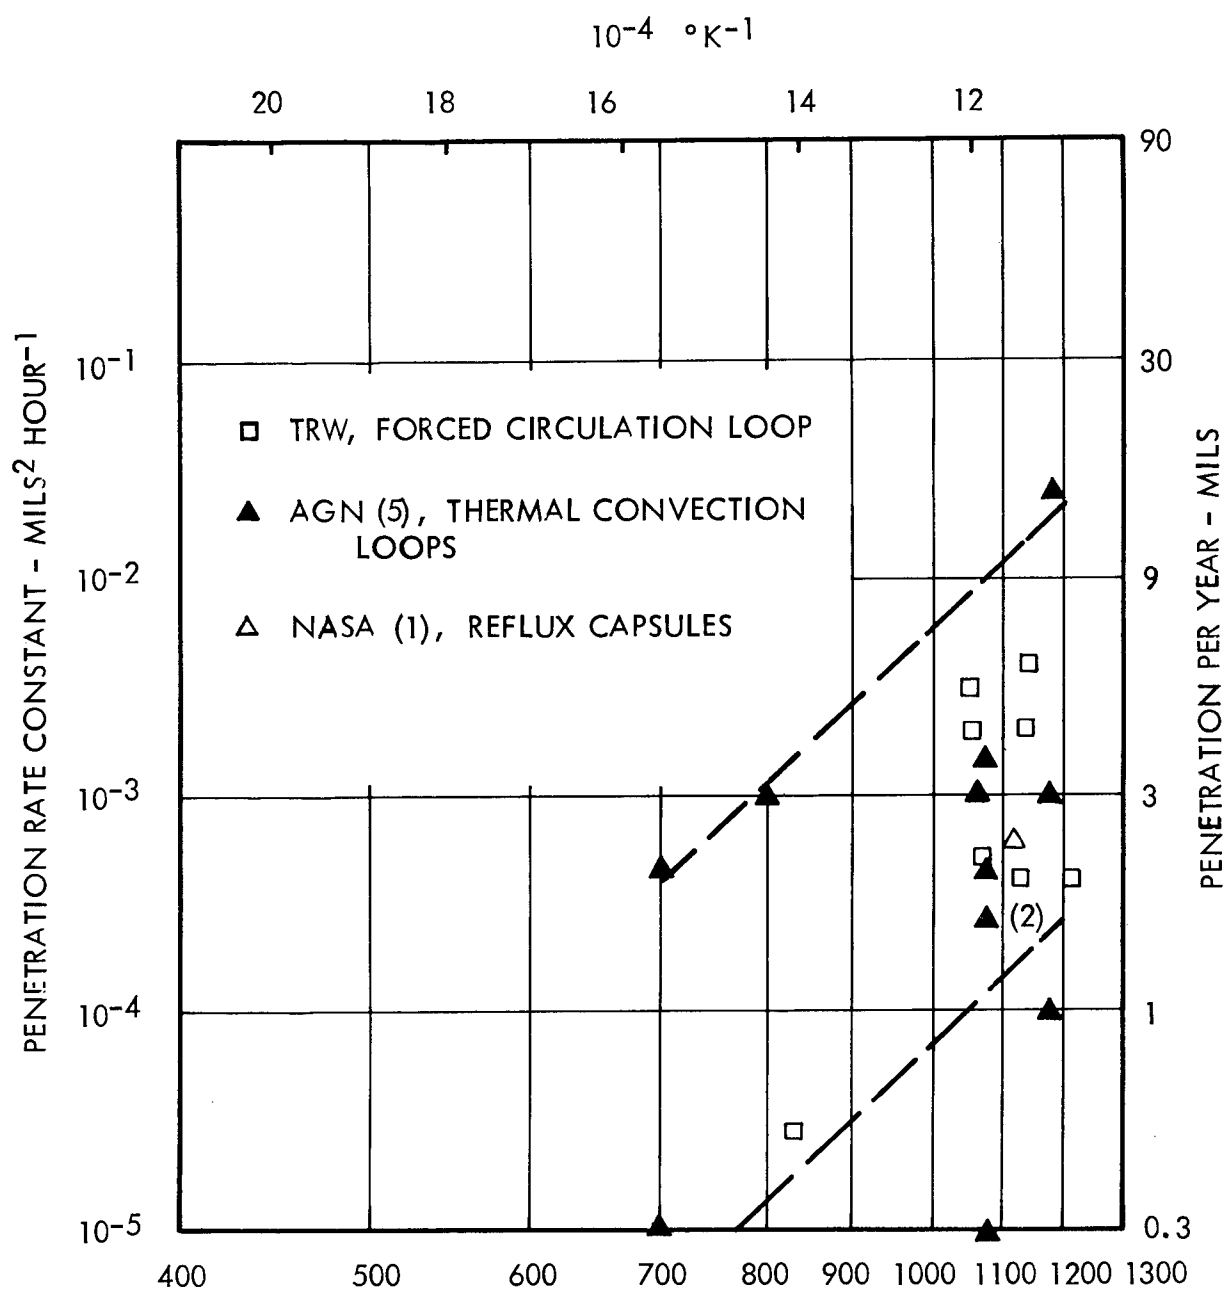
Figure 39. Plot of Corrosion Data for Croloy 9M Assuming Diffusion Control.

The corrosion capsule test results of other investigators⁽¹⁾ indicate that the corrosive attack by mercury of Croloy 9M is of the order of 0.8 mil penetration after 1000 hours at 1100°F. Thermal convection loops operated for 1000 hours at a boiling and condensing temperature of 1075°F (7.2 lbs/hr flow rate) revealed corrosive penetration of Croloy 9M to a depth of 1.2 mils⁽⁵⁾. A comparison of the corrosion data obtained from the operation of this loop with the above referenced results was made. The data compare favorably, as shown in Figure 39, which is a plot of these data assuming diffusion control⁽⁸⁾.

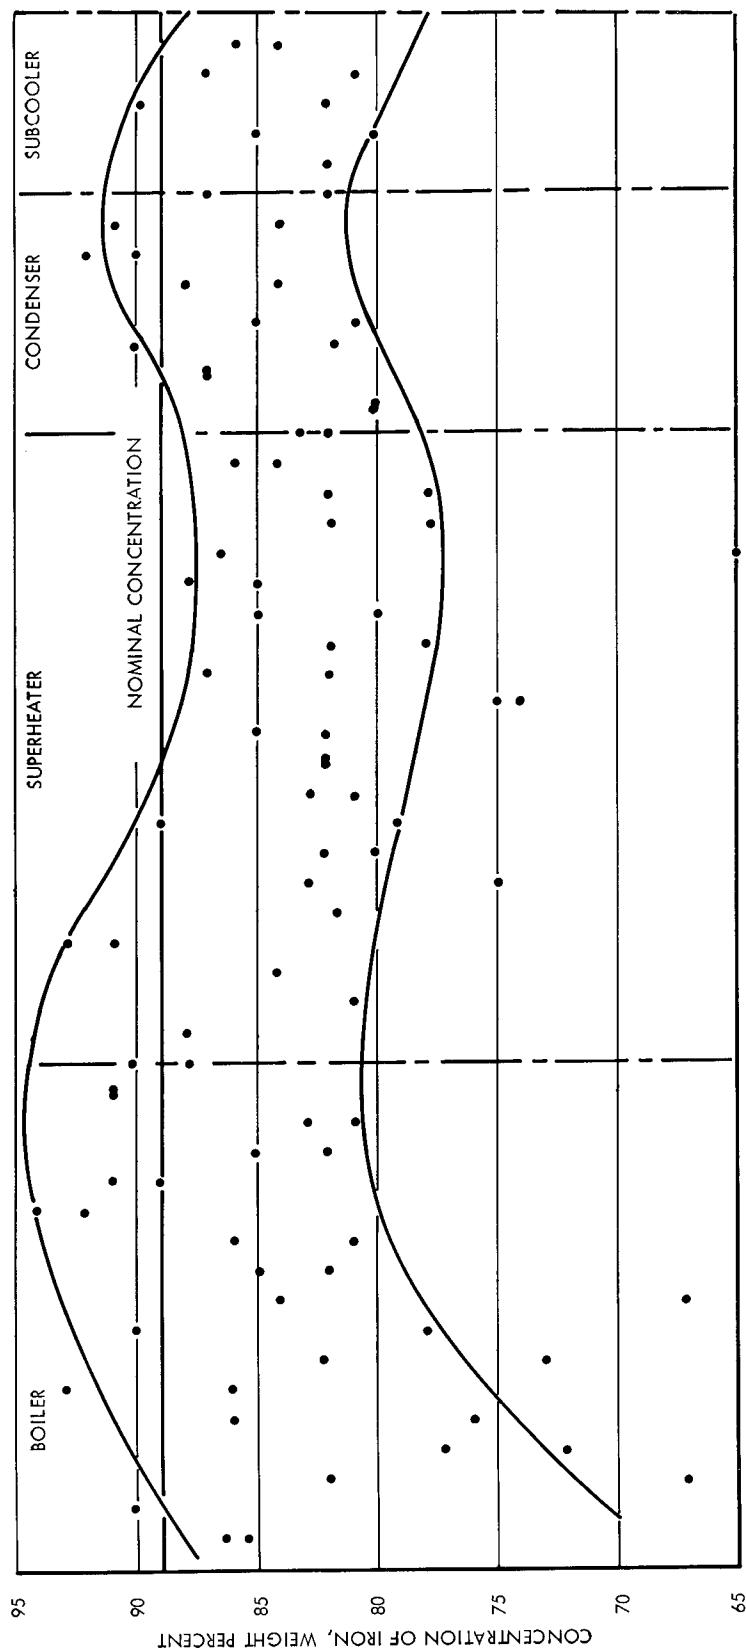
Figure 40. Variation of Iron Content of I. D. Surface with Loop Section.

Two sections of the loop are indicated by this plot to have a depletion of chromium, the last half of the boiler, and the condenser and subcooler. The metallographic examination of the boiler revealed the severest corrosive attack by mercury and thus may substantiate this low chromium content. However, the low chromium content of

the condenser and subcooler ID surface cannot be explained by the metallographic results.

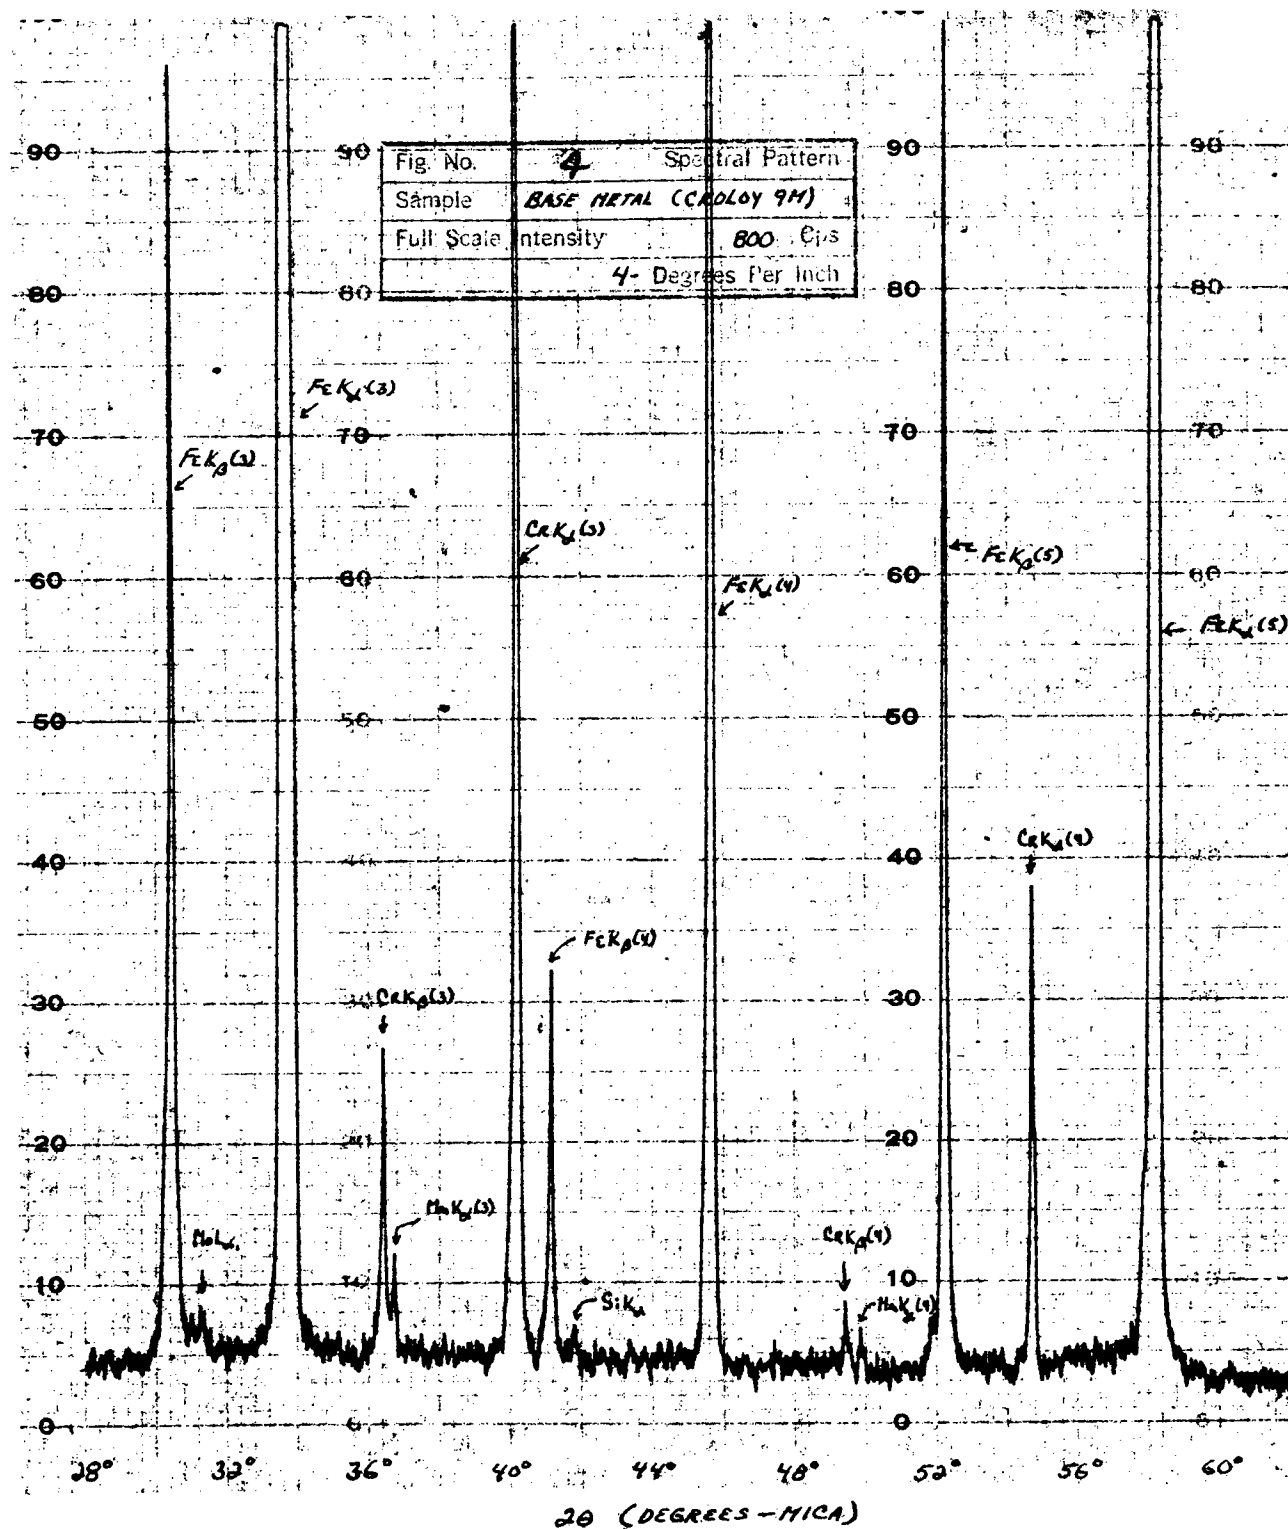
Figure 45. Spectral Pattern of Croloy 9M Base Metal.

An electron beam microanalysis was performed on the larger of the two metallic chips and on the deposit by Advanced Metals Research Corporation. A careful comparison of the iron, chromium, and molybdenum x-ray line intensities for the base alloy and the metallic chip revealed no significant differences, as seen in Figures 45 and 46. In addition, the manganese and silicon content of these two zones appeared to be identical. It is thus apparent that the metallic chip is Croloy 9M, probably a residual particle remaining in the valve after fabrication of this component.

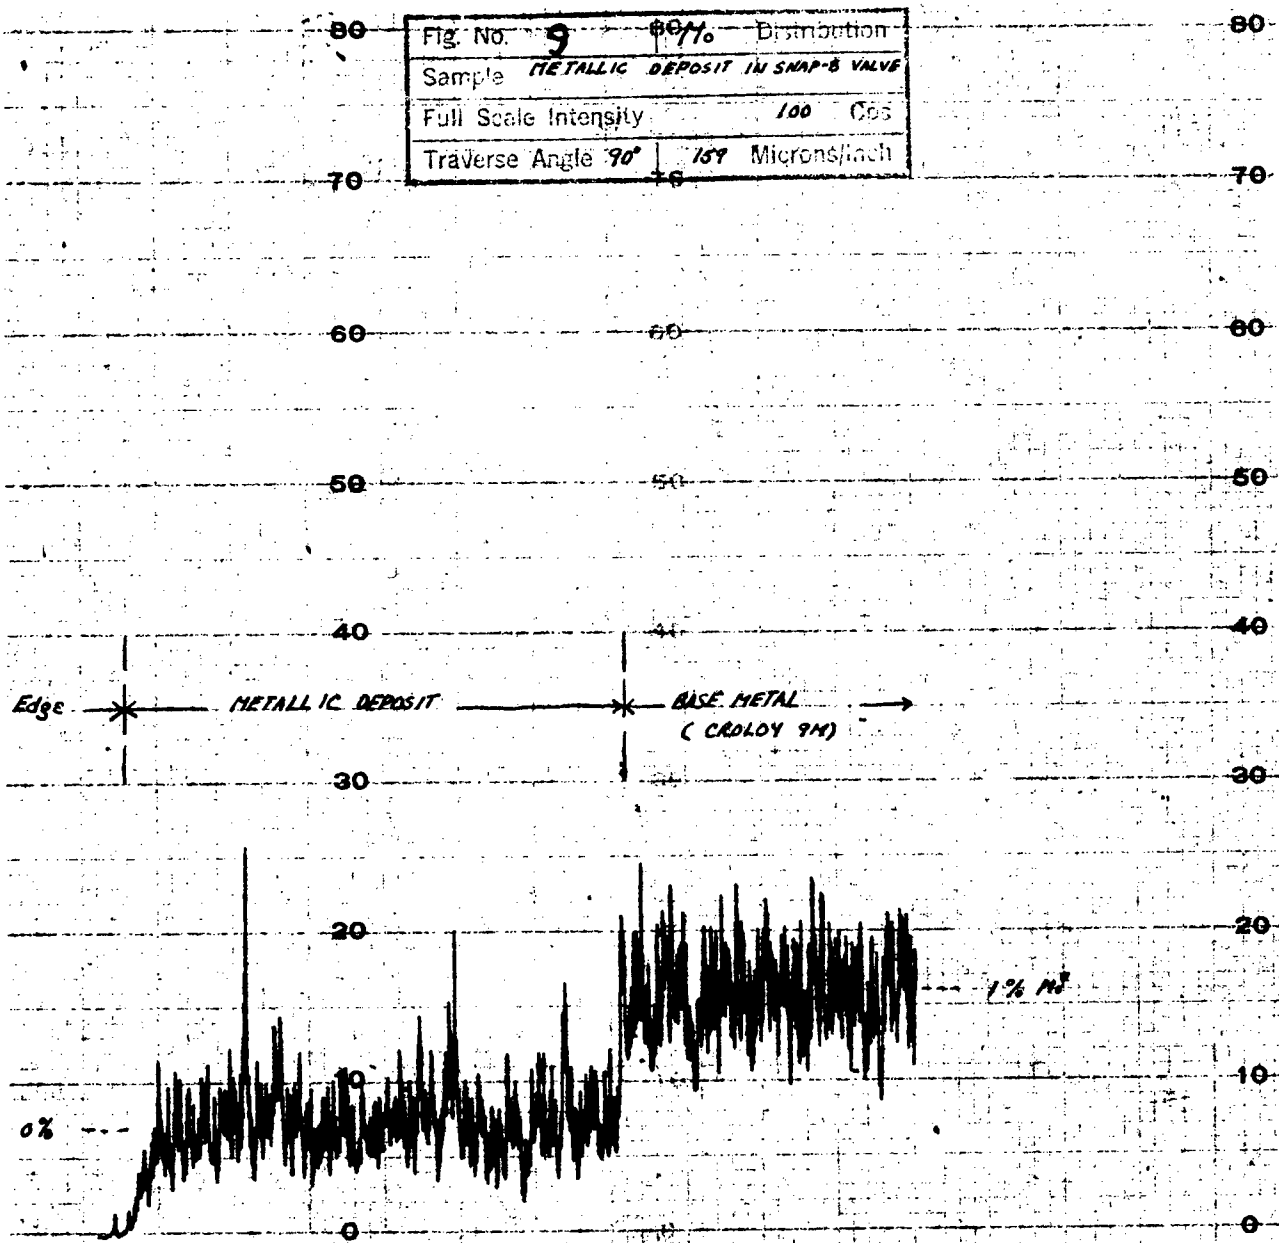
Figure 49. Distribution of Molybdenum in the Deposit Found in the Croloy 9M Throttling Valve.

and the base metal as evidenced by the sharp intensity spikes. These phases are very likely carbides. The balance of 5 to 10 percent material not seen in the analysis (90 to 95 percent iron, approximately one percent chromium and molybdenum) is probably a result of the porosity in the deposit rather than the presence of an additional element. The sharp decrease in both the chromium and molybdenum at the deposit-base metal interface suggests that iron has been removed from another part of the system and has been transported to the throttling valve. This is in agreement with the chemical and x-ray fluorescent evaluations of the remainder of the system.

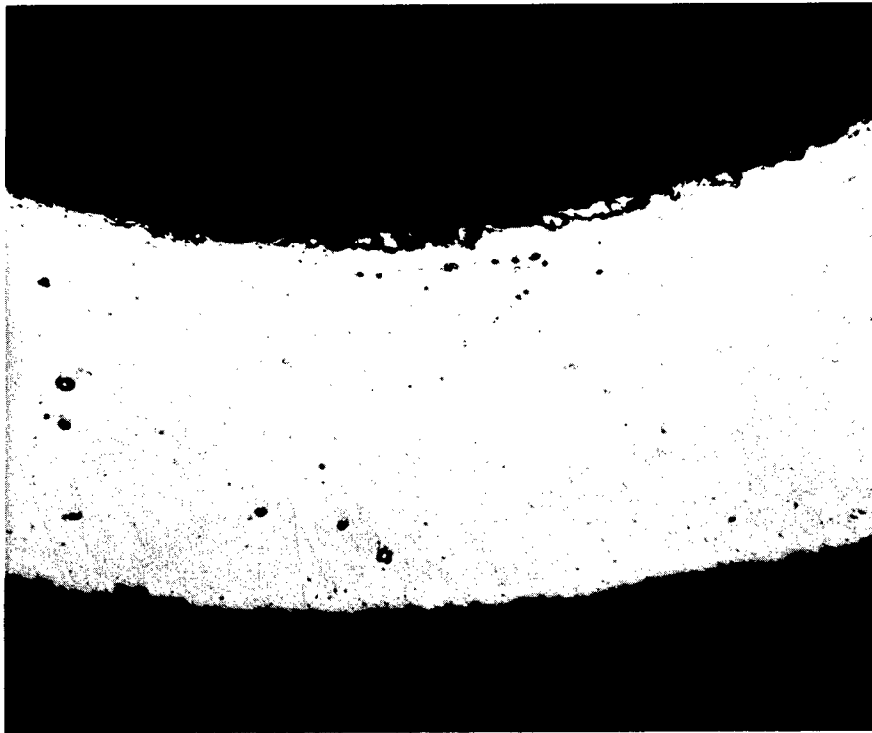
The stem (Croloy 9M) and the bellows (Type 321 SS) from the valve were also examined metallographically. As seen in Figure 50, some slight deposition was observed on the valve stem. The stem also suffered some corrosion and/or erosion damage as shown in Figure 51. The maximum depth of attack was approximately four mils. Some slight attack (< one mil) was also observed on the Type 321 SS bellows, as shown in Figure 52.
